construction site and spatial organization

Belvoir, study of the interior castle

Anne Baud and Olivier Guyotat

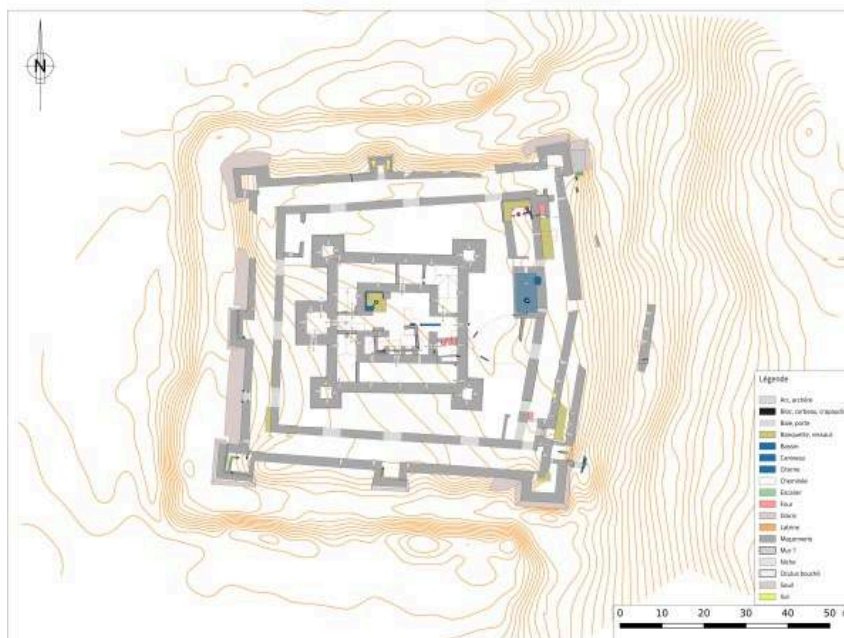
Fig. 2 – General plan of the castle.

The castle of Belvoir has two concentric enclosures (**Fig. 2**)². The first, with a square plan, is surrounded by four quadrangular towers and corresponds to the inner castle, which is articulated around a courtyard with a cistern; the endless hall along the curtain walls supports a floor that has now been completely destroyed. Access to the inner castle was from the west through a tower-gate with a side entry. There is a smaller door on the opposite side, to the east. The second enclosure is pentagonal and has seven towers. It surrounds the inner castle, protecting with its walls various service areas, among which a large cistern and ovens were identified. It is bordered on three sides by an imposing ditch dug in the basalt plateau. The stones from the digging provided the necessary material for the construction of the castle, particularly for the sloping banks of the two enclosures. Unlike the inner castle, the main access is to the east, on the side of the slope leading to the Jordan Valley. This access has undergone various modifications during the successive occupations of Belvoir. Below, the remains of a barbican preserved in the middle of a stone scree, testify to a forward defense.

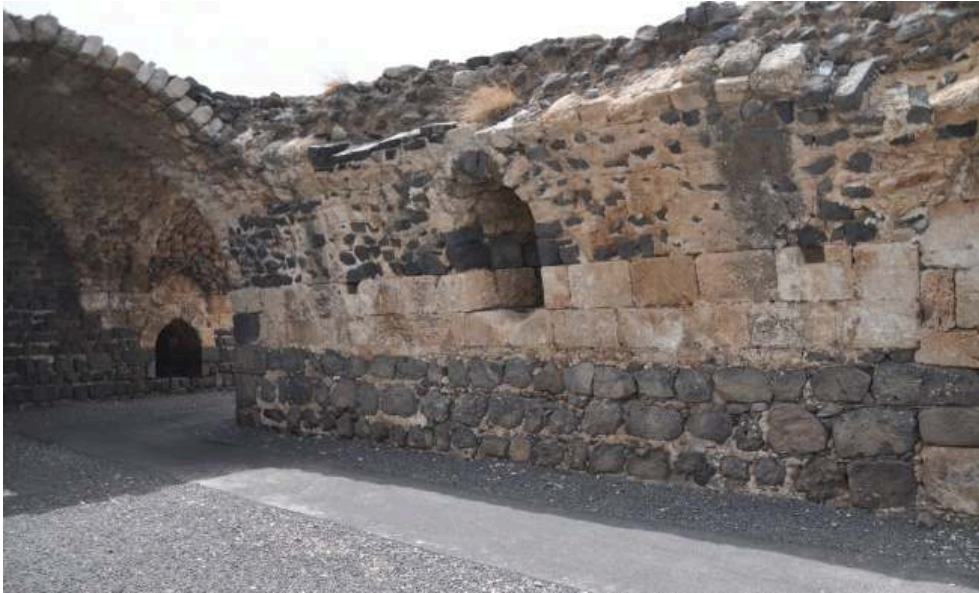
Fig. 3 – The endless hall, north gallery.

For defensive reasons, and probably for prestige, the Hospitallers quickly built the enclosure until the sloping banks were completed. They used rough-cut basalt blocks with stapled stones⁴. A continuous break in the wall stuffing at the top of the sloping bank and at the back of the vault's springer indicates a break in the construction. First, the builders continued to elevate the enclosure by using stones with bossing of white rough limestone for the exterior facing⁵. This elevation leaves a 60 cm reserve in the thickness of the wall for the future vault. The internal walls of the “endless hall” were built, simultaneously, or with a slight offset, which determined the square of the courtyard. Finally, a pointed barrel vault was put over the room. The top of the walls still carries negatives of the arches. The vaults are made of ragstones or, more precisely, of “scrap” in basalt or white limestone. They are supported, on both sides of the room, by a base of two courses of white limestone ashlars resting, on the enclosure side, on the top of the sloping banks. The south-east and south-west corners are groin-vaulted, while the north-east and north-west corners are covered by penetration vaults. All masonry, walls and vaults, are carefully constructed. If the mortar used in the bonding of the stones is thin and of poor quality, it is on the other hand abundantly structured with cut waste (limestone and basalt), at least at the level of the facings. The joints of the interior and exterior elevations have fishbone incisions, some of them similar to foliage negatives; it is possible that a whitewash or a milk of lime originally covered the entire wall.

The endless hall (Fig. 3)

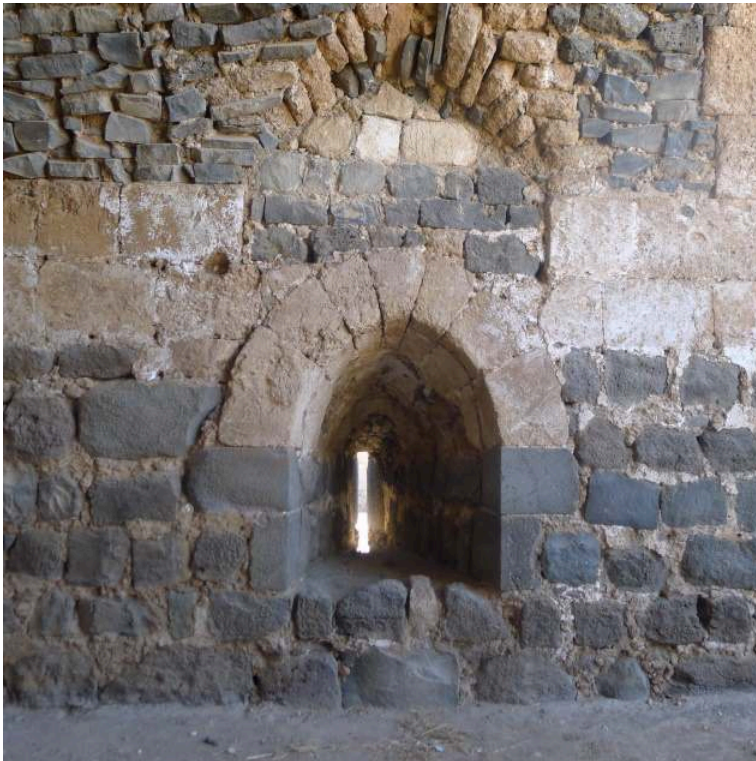
Fig. 4 – Archer in the vault.

The wall of the inner castle is equipped with 28 “whistle” arrow-slits of identical type (Fig. 4). They have a vertical embrasure with interior splaying and a pointed barrel vault. Their unity is reinforced by the exclusive use of white limestone for the arches, creating a bichromy with the basalt jambs. If we examine the insertion of the arrow-slits in the masonry of the walls, we can see that the arches are built with a penetration in the vault, except for two arrow-slits located to the south, whose arches inscribed in the springer of the vaulting required a very precise cutting of the blocks. These two techniques reflect different construction methods, suggesting perhaps several teams

and, more certainly, a search for greater efficiency. The center distances of the arrow-slits, like those of the bays, are irregular. In each case, these “openings” were positioned first and, with their framing stones or jambs, regulated the height of the elevations. In the endless hall, the dividing walls, which are very badly preserved, were built last. Supported by the elevations of the endless hall, they separate rooms that all have access to the courtyard.

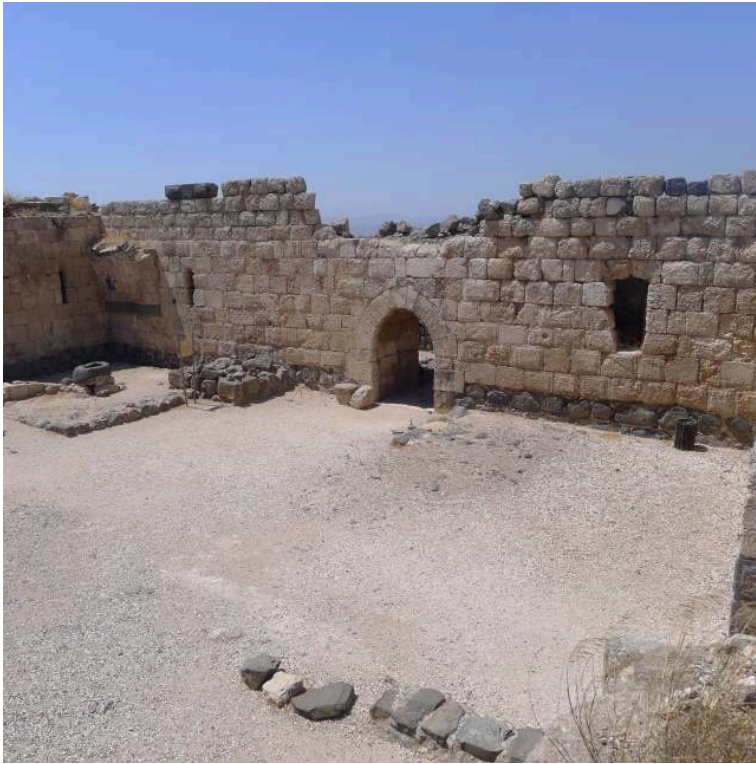
Fig. 5 – Courtyard of the inner Castle.

Situated at the heart of the fortification, the courtyard is a space with many functions: enabling traffic between the rooms on the ground floor and access to the upper floor; it also houses one of the cisterns (Fig. 5).

The walls of the courtyard are made of white limestone. Built with a large fitting of ashlar with tabular bossing, the elevations rest on a base made of two courses of large basalt blocks. The very fine joints of the limestone fitting are shimmed by thin slabs of limestone or basalt from carving waste. Like the sloping bank, the blocks of the base are grouted with a structured mortar of pebbles. This method, which associates hard and soft stones, is rigorously identical to what is observed at the Crac des Chevaliers or the castle of Margat (Syria)⁷.

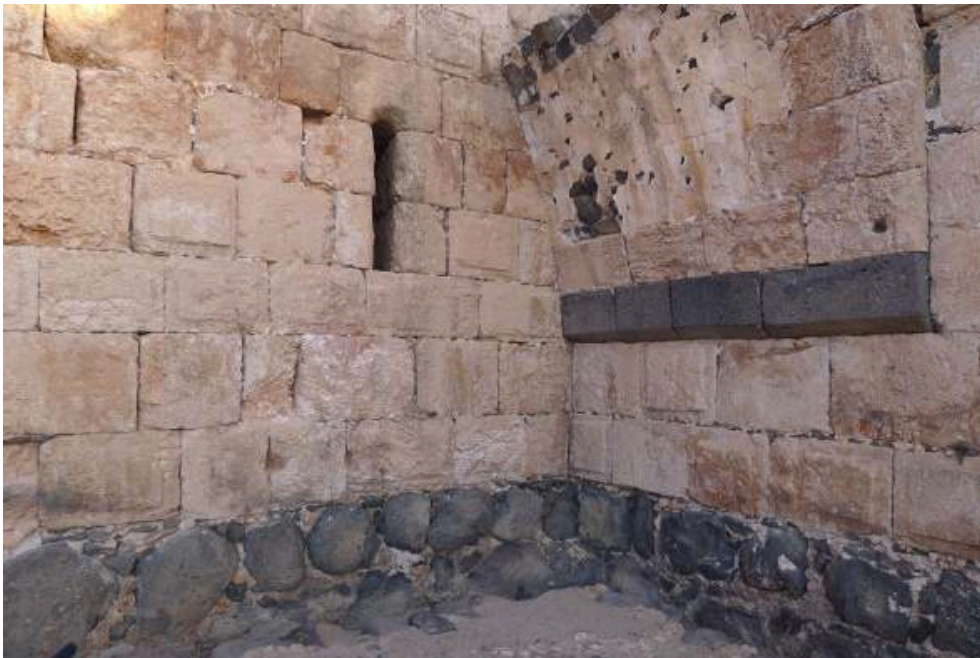
Fig. 6 – Vault inserted in the wall.

create a clearance in front of the chapel, a vaulted structure with very thick walls was attached to the southern vault., completing the condemnation of the western bay. The chapel most likely had a main door to the south, fronted by an open space suitable for the processional entry of the Hospitaller brothers during mass and daily services. This “forecourt” can also be found in the Hospitaller castles of Crac and Margat. However, the disposition of the chapel along an east-west axis was inconvenient, for it blocked north-south traffic on the upper floor. No doubt a second door had to be pierced to the north in order to provide a passage through the chapel or a new access from the north. The location of the chapel on the gate tower also raises the question of its defensive capabilities. It is possible that the chapel itself could have been defended by the opening of arrow-slits in the western bay of the nave. This hypothesis is corroborated by some elements of the lapidary that remain to be studied more closely.

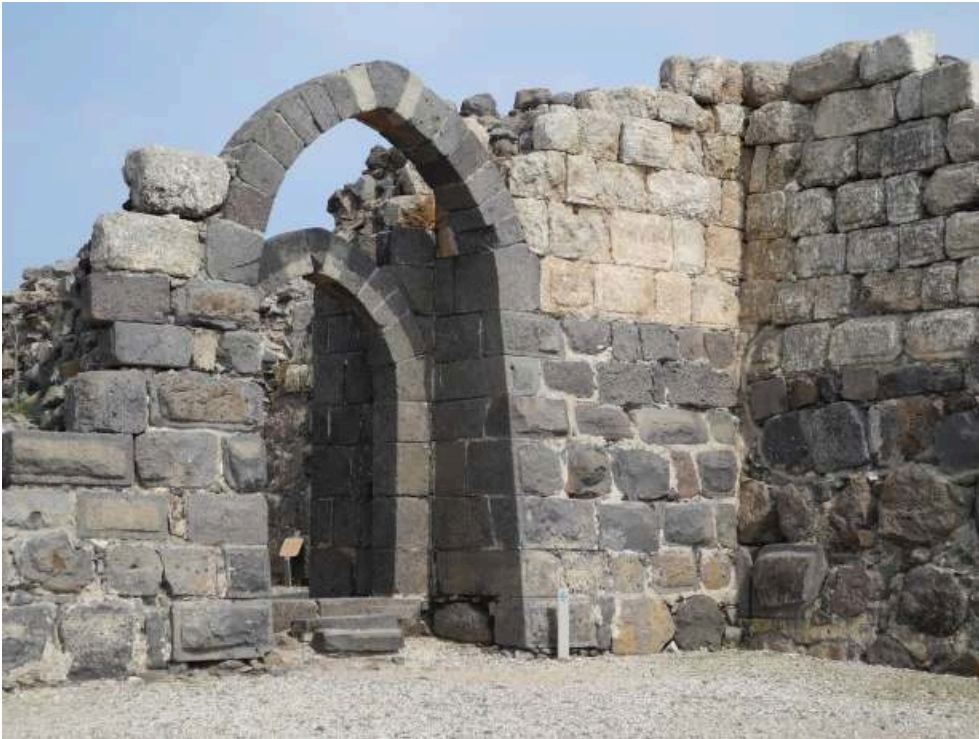
Fig. 7 – The west gate tower.

In organizing the space, the east-west axis was clearly privileged and enhanced at the start by two large monumental doors; today, only the western door remains in its entirety. Each of the doors leads to the second enclosure, beyond the endless hall, through a passageway with a groin vault. The analysis of the plan and elevations reveals that the installation of the upper floor was concretely organised only once the first floor had been completed. This must have been done hastily and led to pentiments and architectural inconsistencies. A careful observation of the place (ground floor and upper level) gives us a better understanding of the chronology of construction and the function of the site.

The chapel was most likely above the gate tower for both architectural and symbolic reasons. This location was confirmed by Meir Ben Dov, who reassembled the southeast corner of the nave from blocks found on site. The location made the chapel visible both from the courtyard and from outside the castle⁸. The arrangement at the top of the tower and the endless hall, to the west, led to a series of architectural and circulatory modifications on the ground floor. In order to orient the chapel, give it a big enough course, three vaults were added against the western façade of the courtyard. To the north, the insertion of the vault is clearly visible (Fig. 6 and 7); to the south, it partially condemns the western bay. To receive the top of the ramp on the upper floor and to

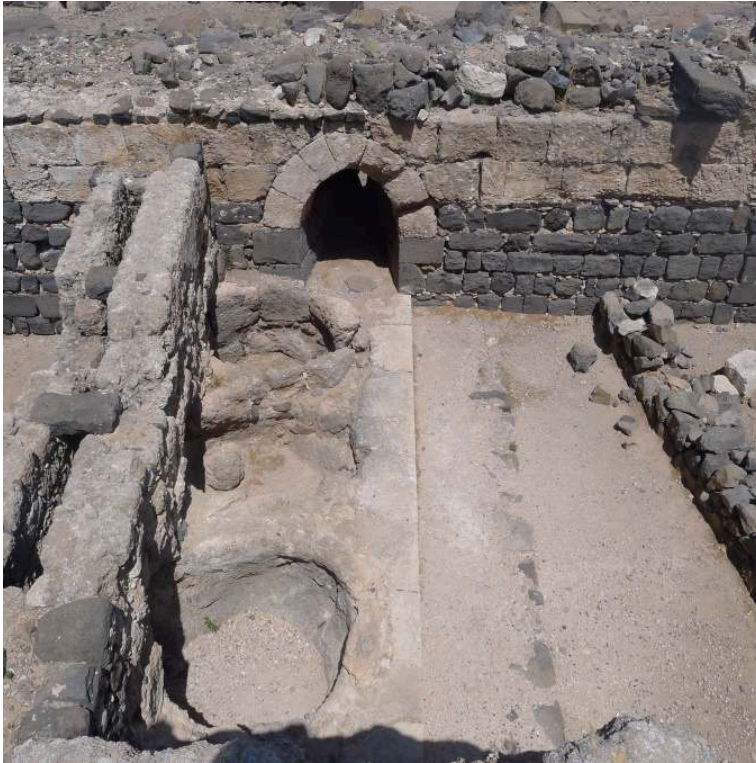
Fig. 8 – The three ovens.

In the southeast corner of the courtyard, the door partially closed by the ramp gives access to a room with three ovens (**Fig. 8**). They are aligned along an east-west axis, slightly moved to the north to allow access to the arrow-slit immediately nearby. The cooking space is delimited to the south and north by two walls resting against the elevations of the endless hall. To the south, the 0.60-m-wide wall still stands at 0.10 to 0.60 m high⁹. It is made of basalt blocks shimmed together with numerous fragments of limestone; to the north, the wall, which is now heavily damaged, curiously rests against the jamb of the large arcade to the west, revealing the rapid modification of the original plan. In its northern part, a small doorway with a 0.90-m-wide threshold and associated with a door socket, was probably used to bring in the wood. This doorway provided a direct connection between the eastern door of the inner castle and the oven firebox. Studying these ovens leads to the question of their function: were they attached to the “castle kitchen” or were they used to manufacture sugar, as the morphology of their structure seems to indicate¹⁰? We note, moreover, that the support of the arrow-slit has been re-cut into a conduit, thus indicating the alteration of a first (?) military function. It is in this same culinary (or other) space that is located the only staircase from the fortification still preserved, except for the banister. It is a service staircase built into the thickness of the eastern wall and accessible by a few wooden steps. It goes above the door and leads to the northern rooms. This room does not seem to have originally been designed to house ovens. If they were installed at a later date, it is still difficult to determine the exact time, but the position of the chimney shows that the vaulting of the first floor was probably not yet completed. One may wonder

whether the place did not become a kitchen or a sugar-production workshop because the construction of the ramp had partially blocked the monumental door¹¹.

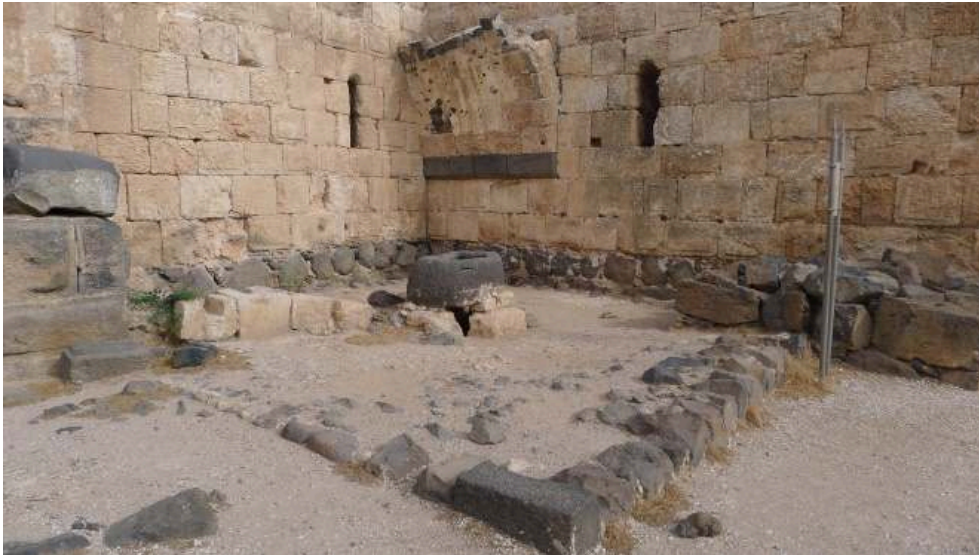
Fig. 9 – The small tank.

The inner courtyard of the castle houses a cistern in its northwestern corner (under the northern vault) with a fairly well-preserved hydraulic system (Fig. 9). The mouth of the cistern, cut into a basalt slab, is not original. A careful cleaning of the structures, accompanied by a careful reading of the elevations, has made it possible to reveal a rainwater collection system on the upper floor of the castle¹². Built of limestone, the walls and the vault had two layers of plaster. Rainwater was collected from the floor through a pipe against the wall¹³. The pipe is gone, but its negative remains along the facing. The water reached a settling tank whose interior walls were protected by three layers of plaster: the first one was structured with small stones, the second one was saturated with ceramic shards according to a well-known ancient technique, and the third one, grayish in color, also contained a large number of terracotta fragments. This lining gave the basin undeniable hydraulic qualities. The water from the settling basin was then directed to the cistern through a slightly sloping pipe, also coated. Two other pipes evacuating the water towards the courtyard were also located. Prior to the restoration of the grounds by the Parks Department, we were also able to identify a large pipe that crossed the courtyard from west to east, passing under the threshold of the east door of the interior castle and continuing to the large cistern (rectified photo). It is probable that in case of “overflow,” some of the rainwater was directed from the small cistern to the large cistern in the second enclosure. If the cistern was being built at the same time as the castle's foundations, the settling basin was installed against one of the supports of the vaulting, which was built at a later date, as we saw for the

construction of the chapel's apse. This observation tends to confirm that the building-modifications linked to the installation of the upper floor had been indeed contemplated from the outset, but that they result from a series of changes carried out on the basis of a centripetal modular plan. The cistern was first excavated by Meir Ben Dov. He found most of the carved blocks that are now in the National Museum in Jerusalem. However, we still don't know when these blocks, which were not reused in Arab houses, were put aside and preserved from deterioration.
